ZERRINGER.SnapOn.Stone.Subframe

Limestone. Frame details

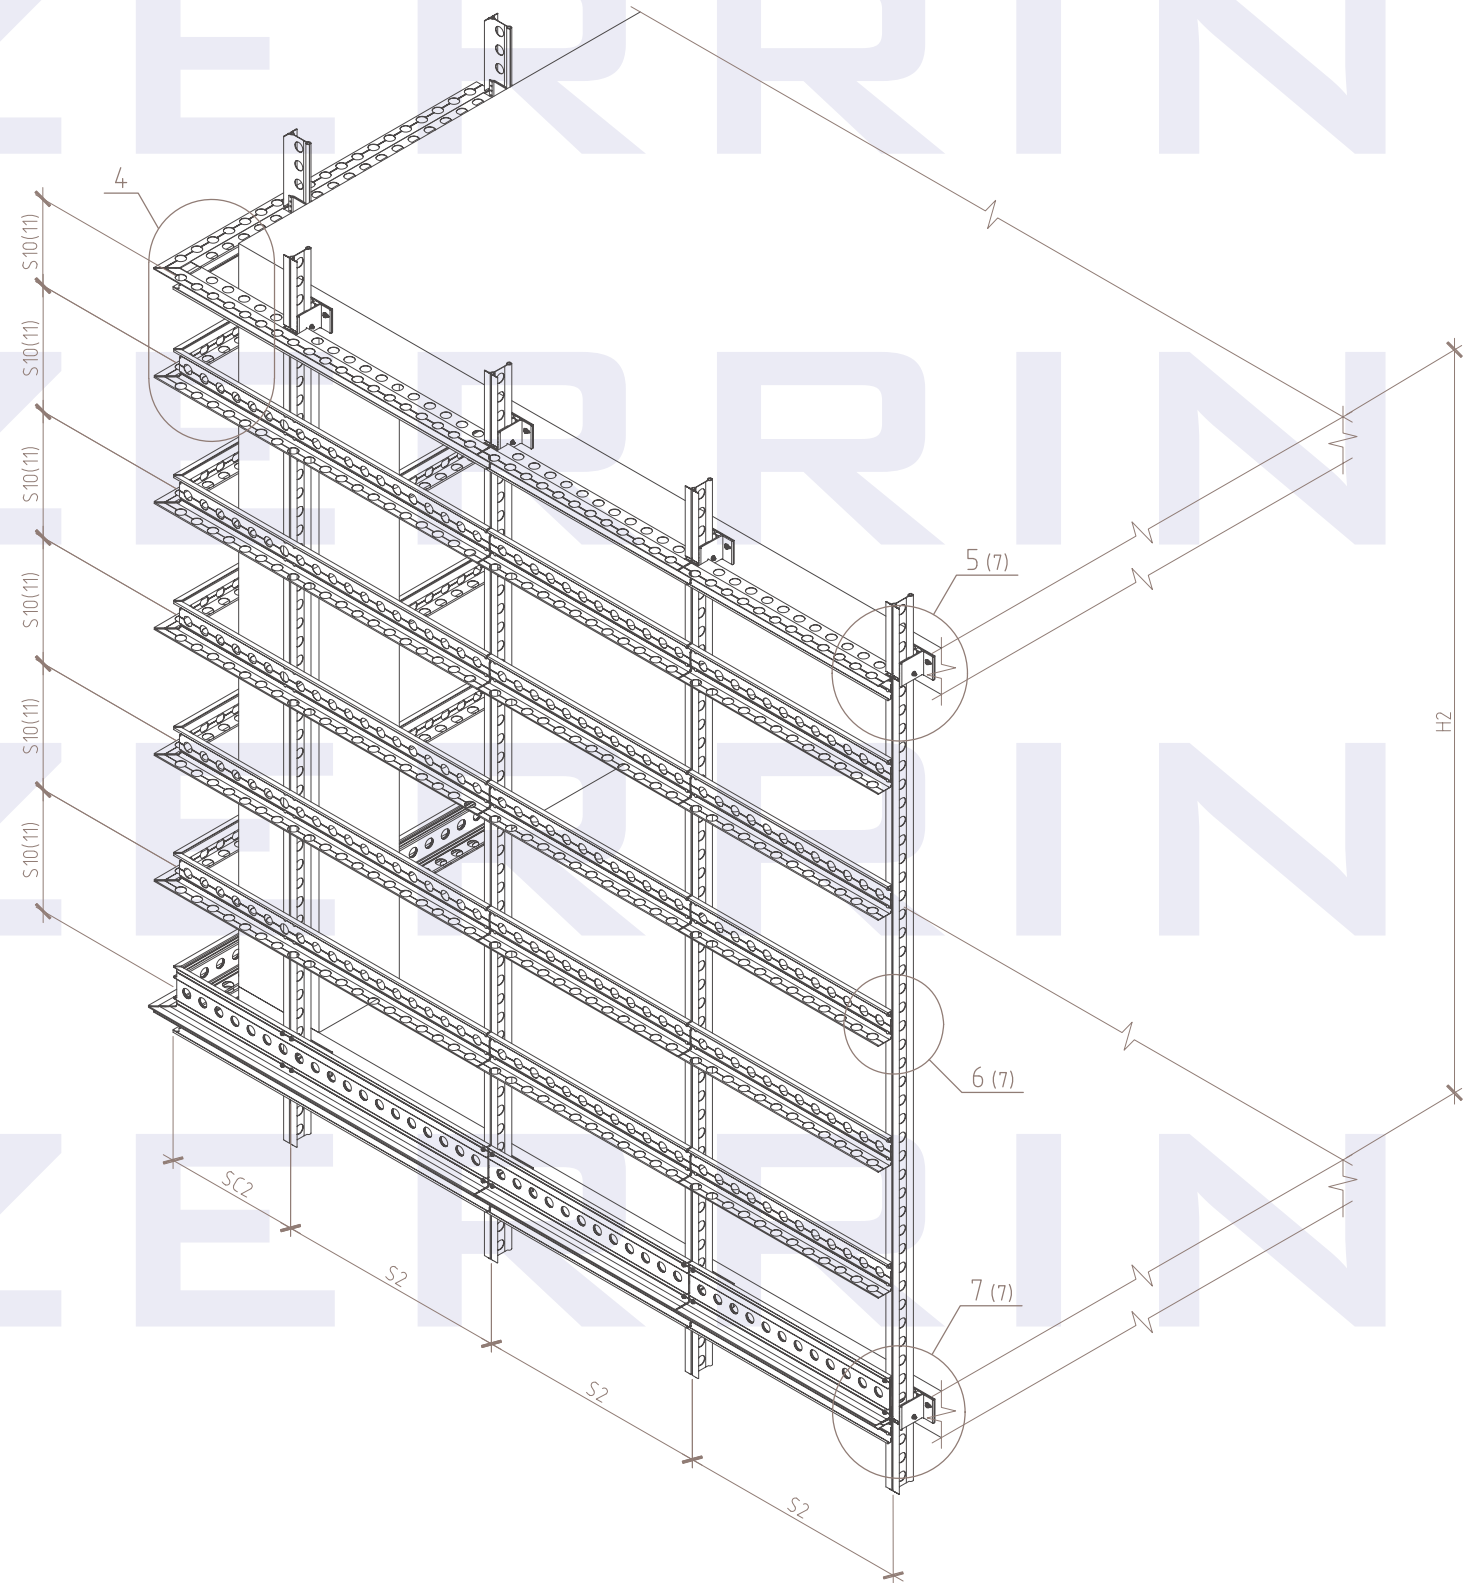
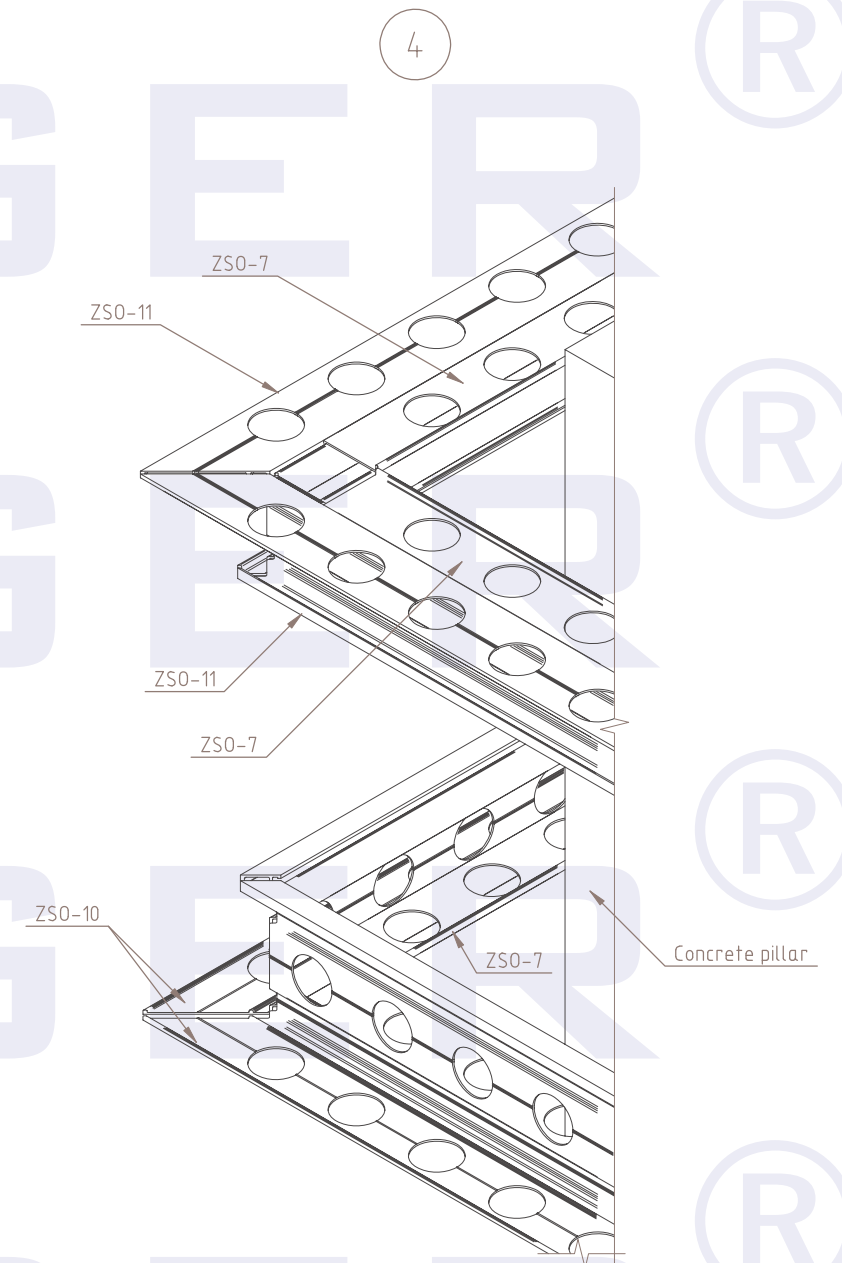
ISOMETRIC VIEW

Stone subframe

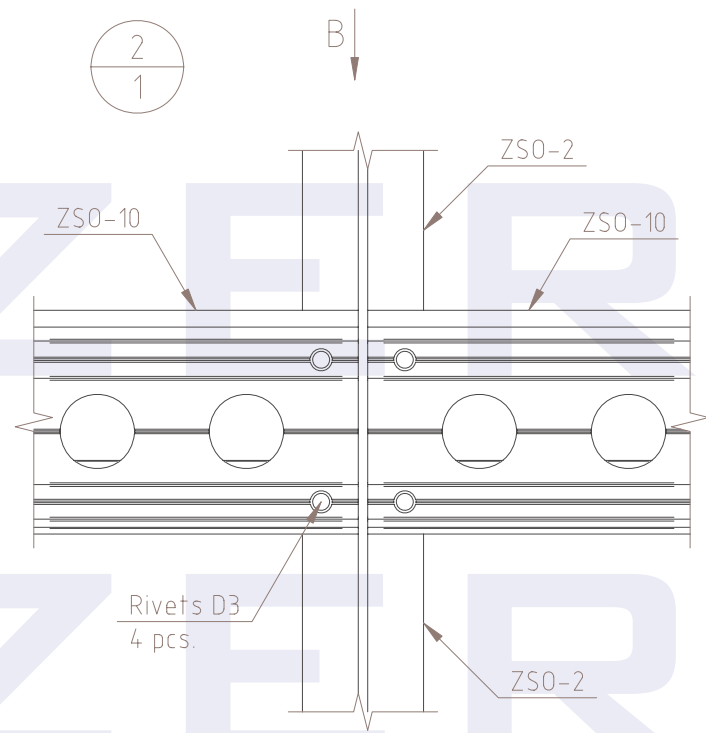
Fixing detail (D3)

Fixing method:

- blind rivets
- thread cutting screws

Rivets (according to stress calculations) -

- 4.8 - Al(Mg 3.5)-ST DIN 7337;
- 6.0 - Al(Mg 3.5)-stainless steel AISI 304 DIN 7337.

Anchors - HILTI HIT-RE 500 - HAS (HAS-5.8, ISO 898 T1, galvanize min 5 mkm, HAS-R stainless steel A4-70; 1.4401, 1.4404, 1.4571).

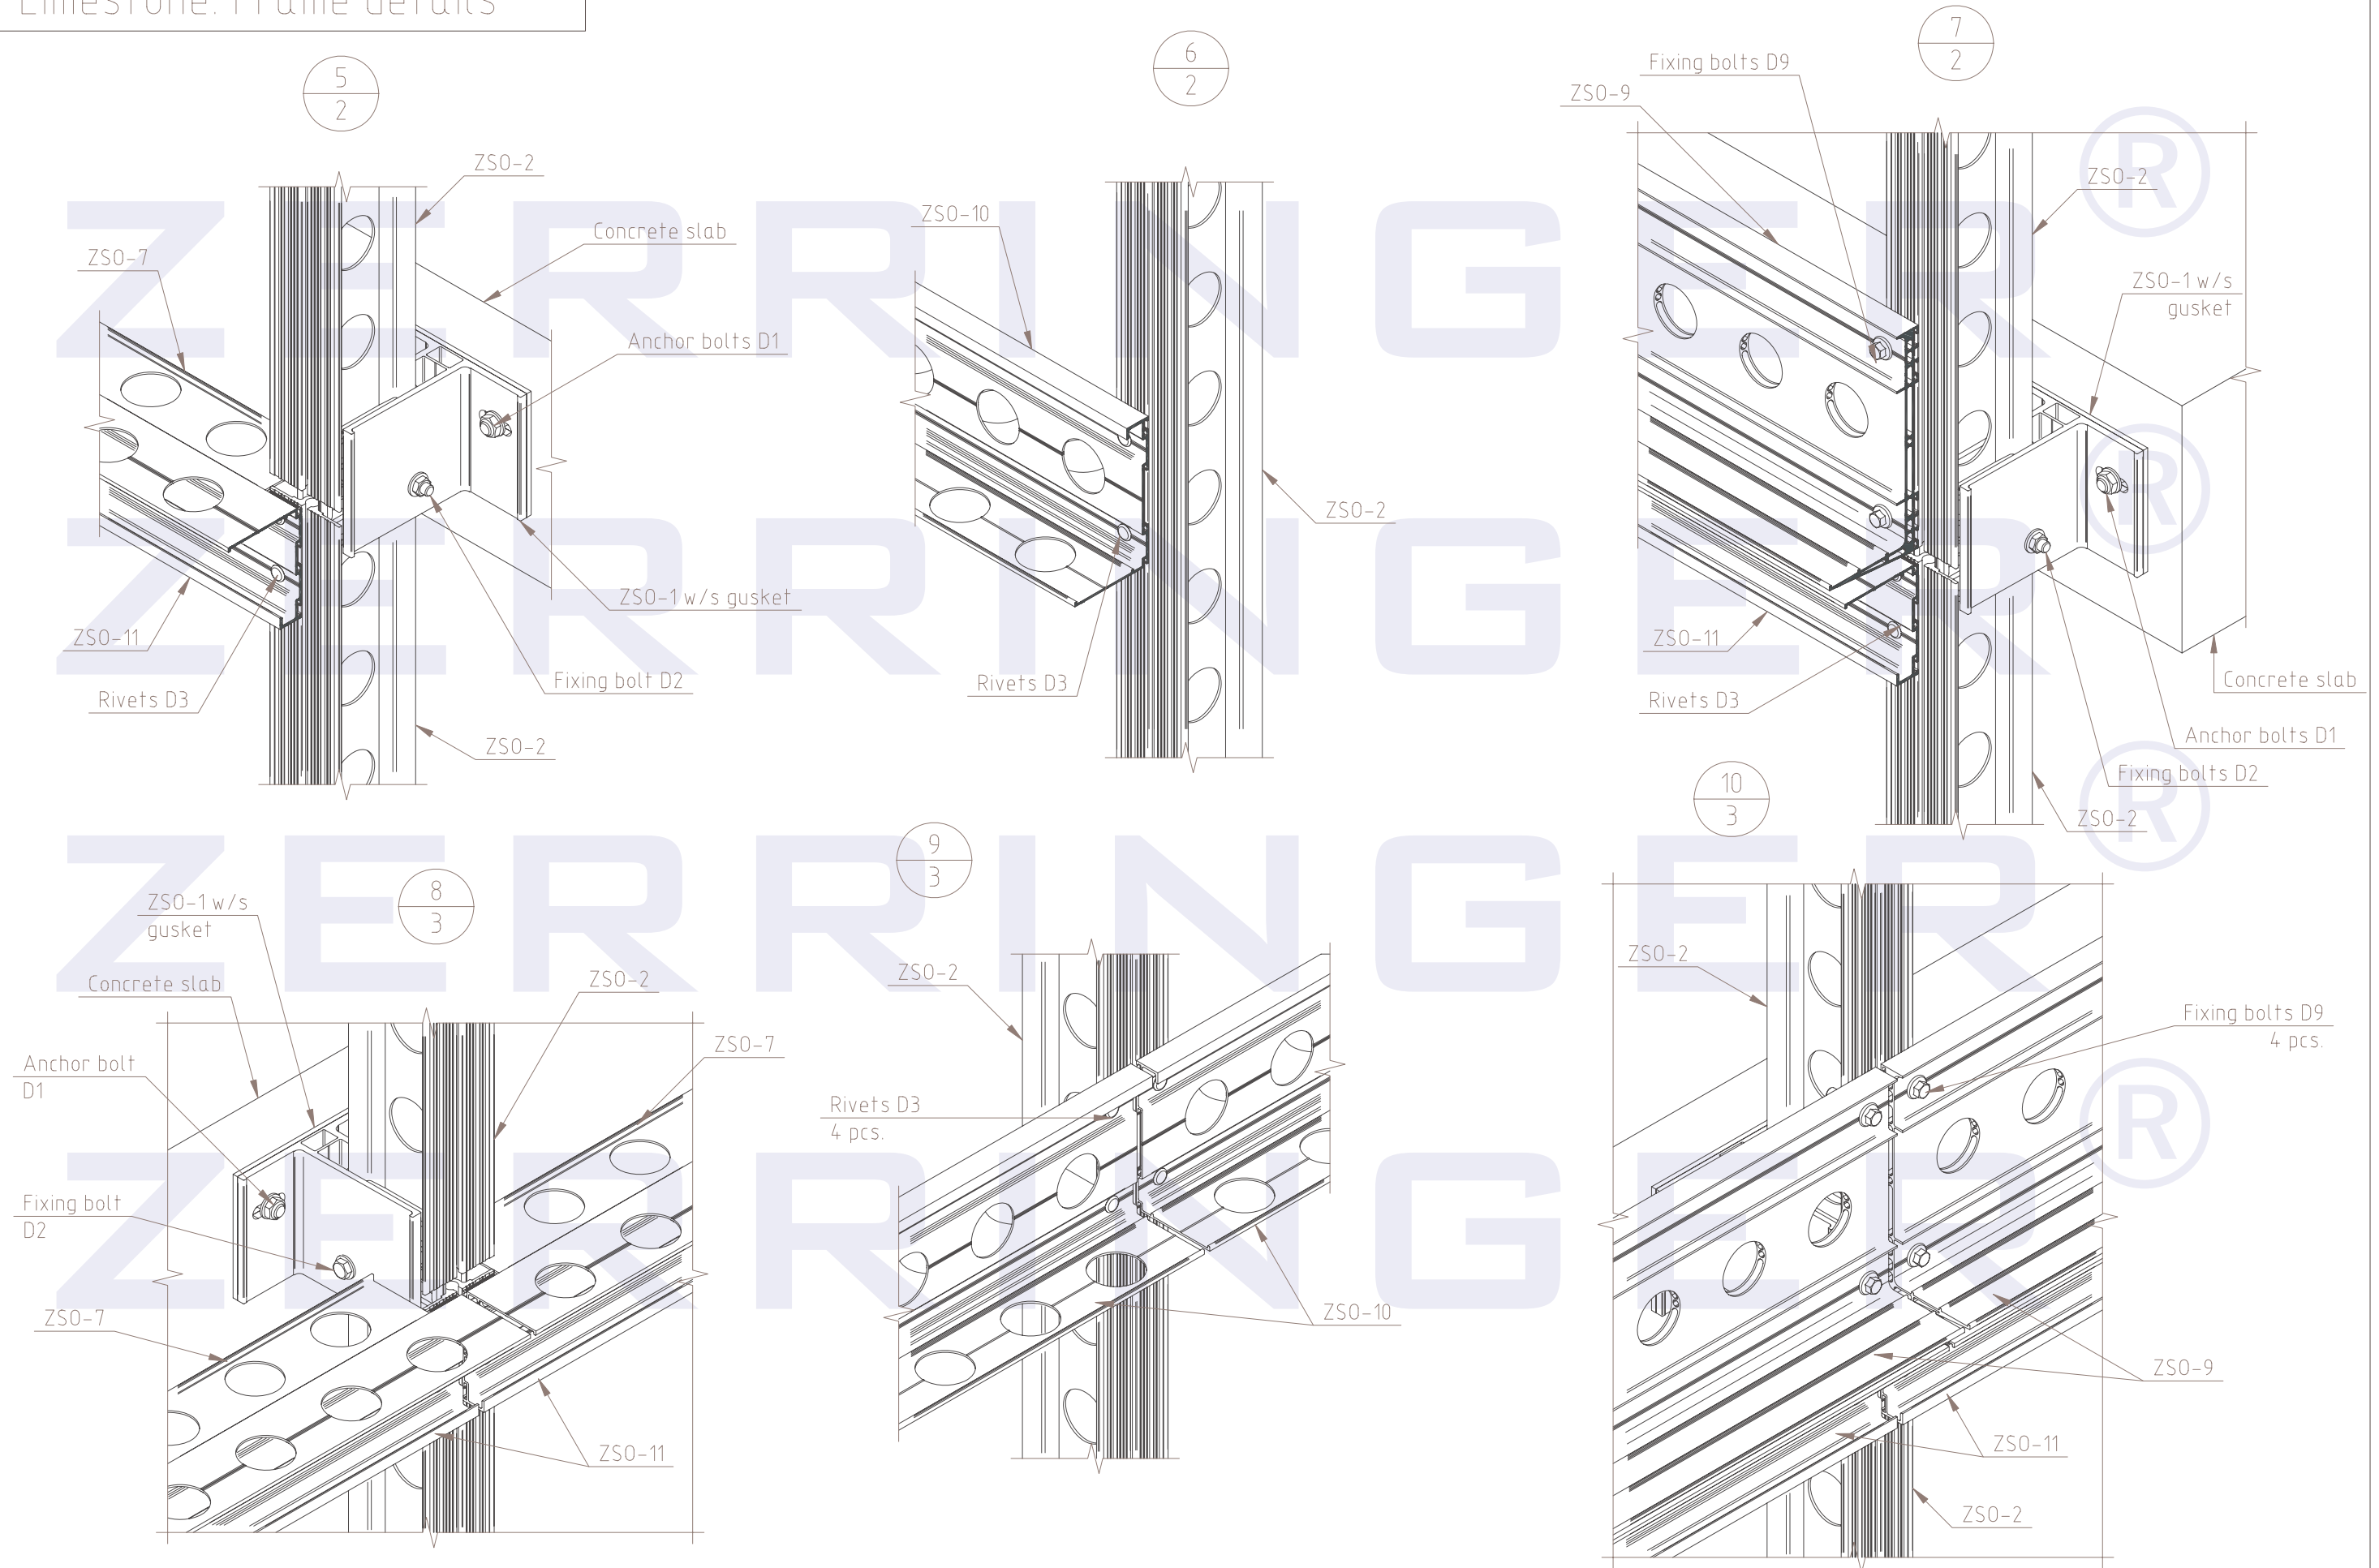
Self-tapped bolts - TEX 4.8x13, 4.2x16 DIN 7504 N
